Natural Conditions Assessment for Low pH and Low Dissolved Oxygen, Hornquarter Creek in King William County, Virginia

**Submitted by
Virginia Department of Environmental Quality**

December 2011

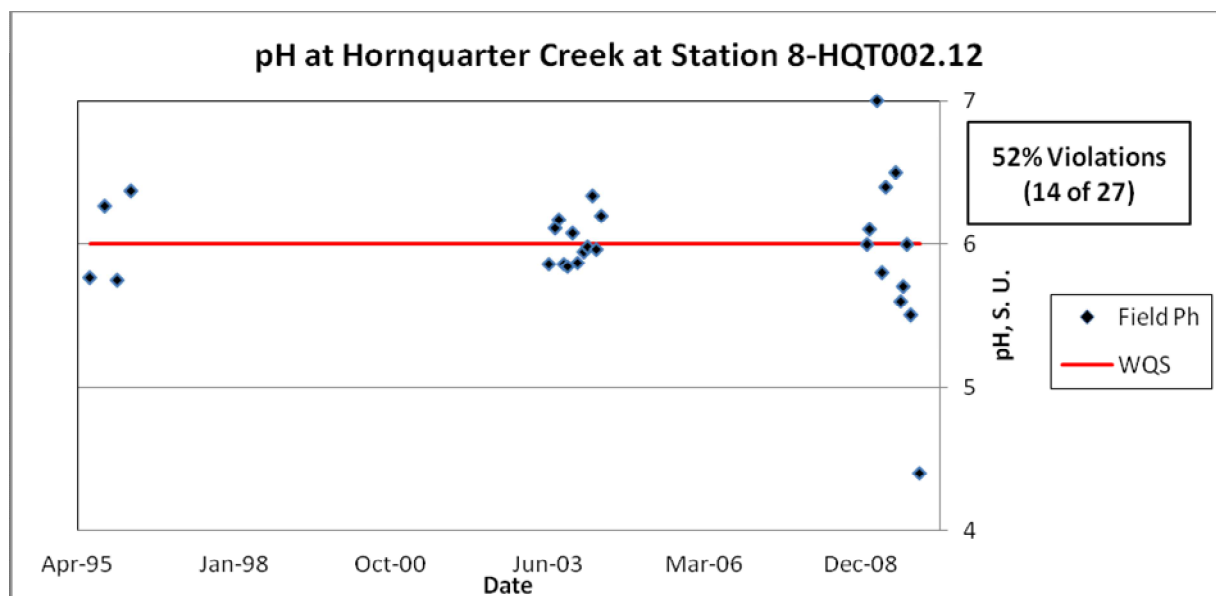
Figure E1. pH concentrations at Hornquarter Creek station 8-HQT002.12.

DEQ monitored 2 stations on Hornquarter Creek with dates ranging from June 1995 through December 2009. Of the 29 total pH data points recorded, 15 violated water quality standards for pH (52%), and 3 of 31 DO data points violated the water quality standards for DO concentration (9.7%). The 3 DO violations occurred at the original listing station 8-HQT002.12 resulting in a violation rate of 10.7%. The landowner of the upstream station (8-HQT004.62) denied access after the third visit, therefore only three samples visits were made at that site. Figures E1 and E2 show respective pH and DO concentrations at the listing station 8-HQT002.12.

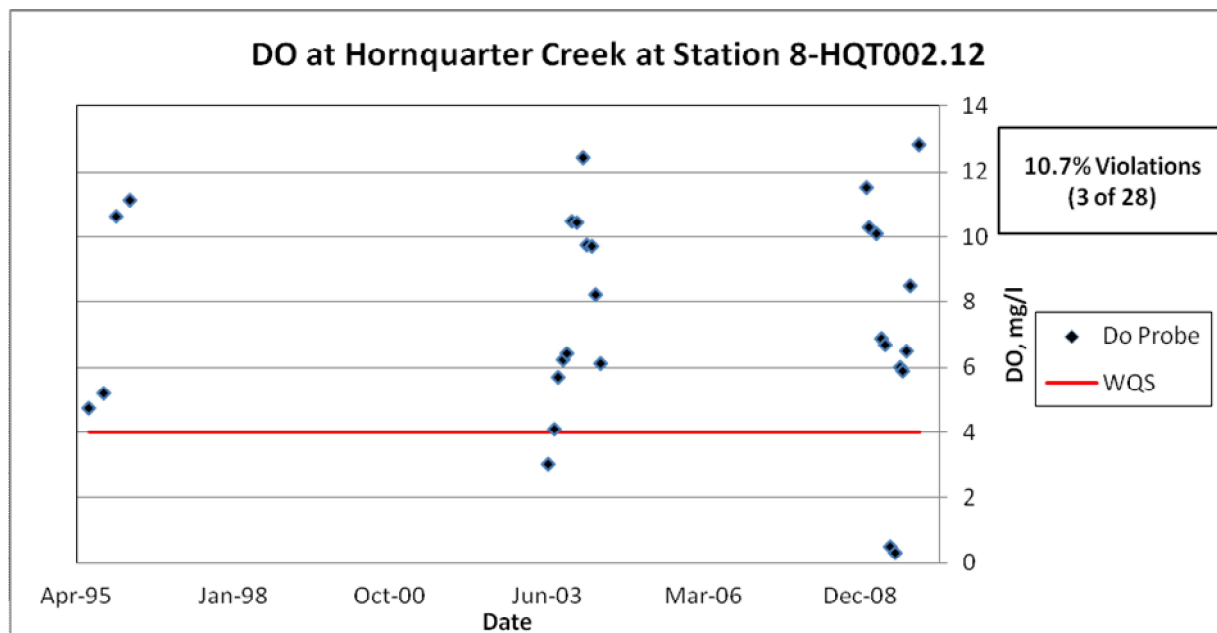
Figure E2. DO concentrations at Hornquarter Creek station 8-HQT002.12.

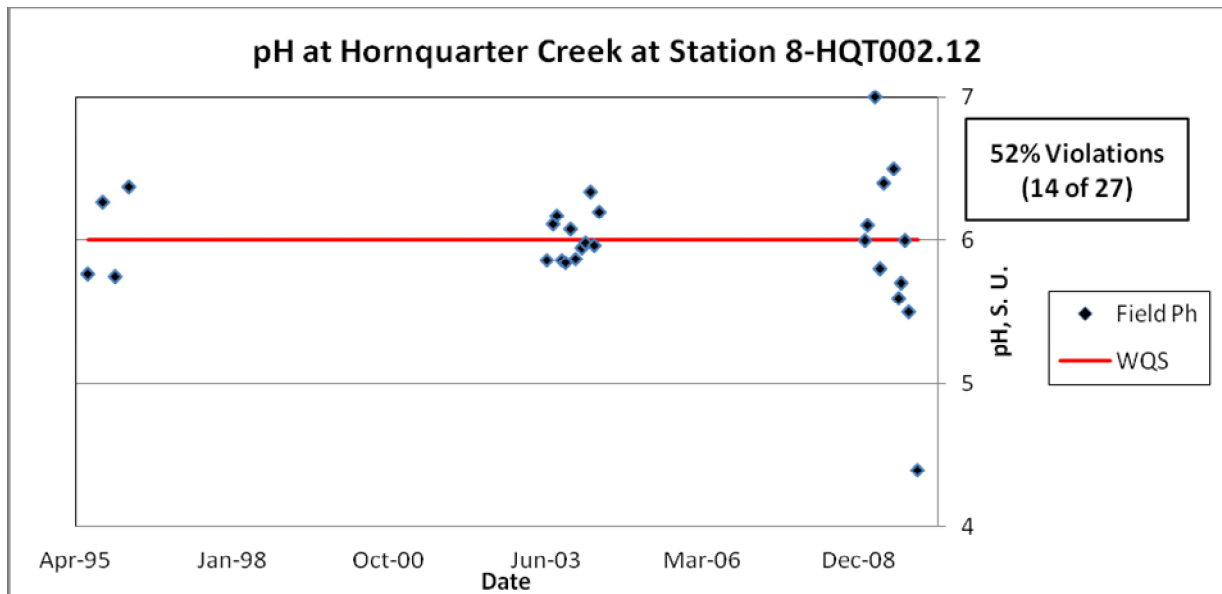
Figure 4. Time series of pH at Hornquarter Creek station 8-HQT002.12.

Time series graphs of all pH and DO data collected at the original listing station, Hornquarter Creek at station 8-HQT002.12, shows the pH ranging from 4.4 to 7.0 S. U. (Figure 4) and DO ranged from 0.3 mg/l to 12.8 mg/l (Figure 5). The horizontal red line at the pH = 6.0 mark represents the minimum water quality standard. The data points below the pH = 6.0 line are violations of the water quality standard in Figure 4. The horizontal red line at the DO = 4.0 mark represents the minimum water quality standard in Figure 5. The data points below the DO = 4.0 line are violations of the water quality standard in Figure 5.

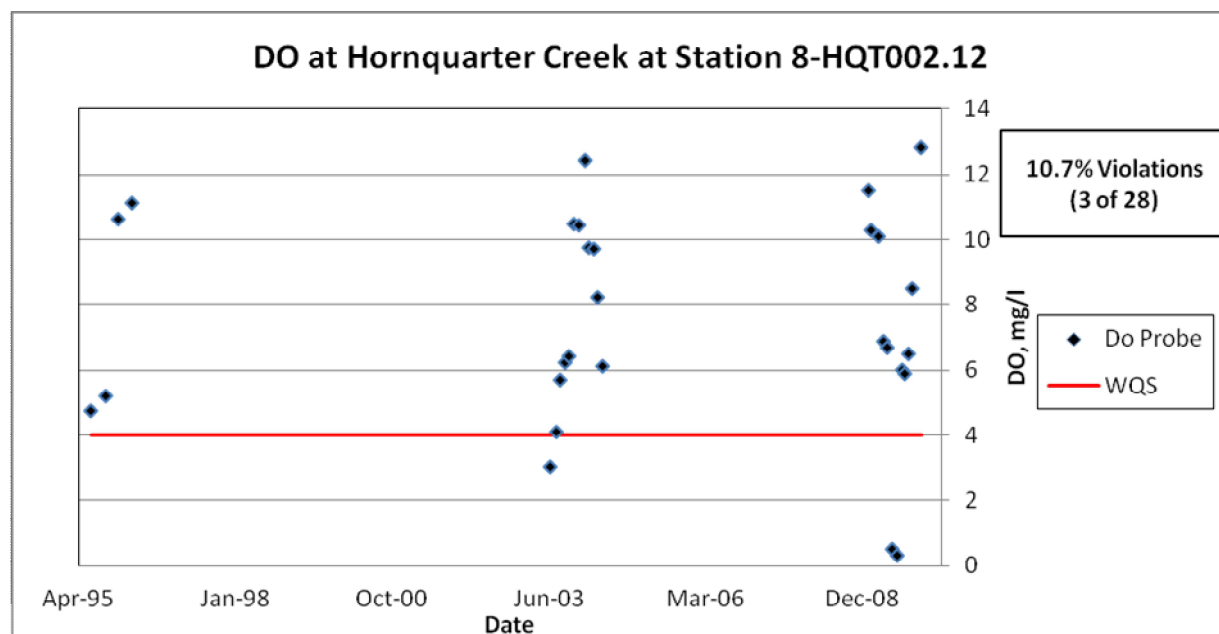
Figure 5. Time series of DO at Hornquarter Creek station 8-HQT002.12.

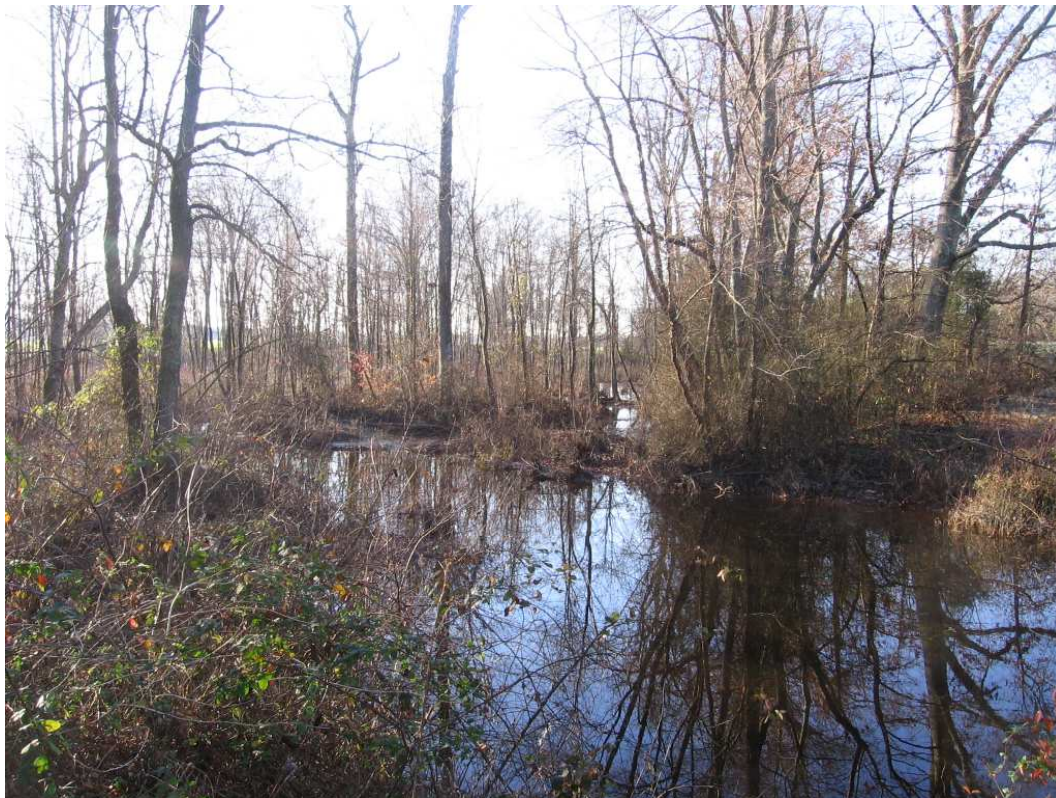
Figure 6. Hornquarter Creek, Rt. 614, Downstream.

Visual inspection of Hornquarter Creek revealed swampy areas with heavy tree canopy. Decomposition of vegetative matter from large swampy areas lowers DO and pH as decay occurs. (Figures 6 and 7).

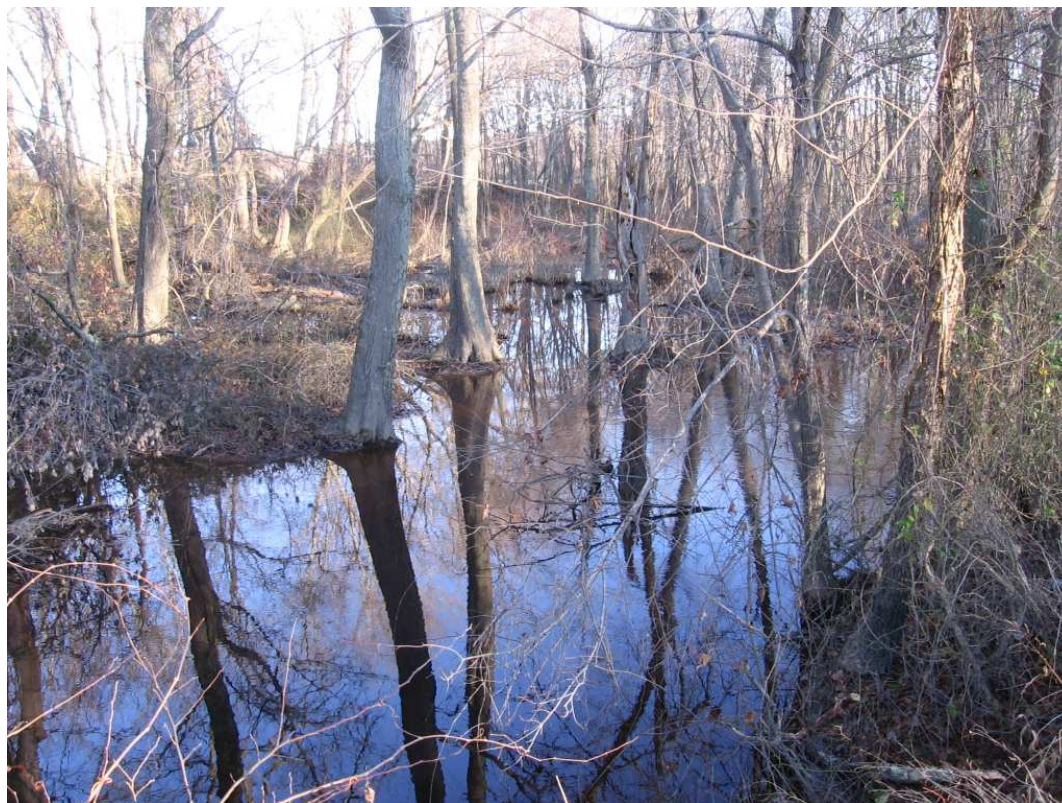
Figure 7. Hornquarter Creek at Rt. 614, Upstream.

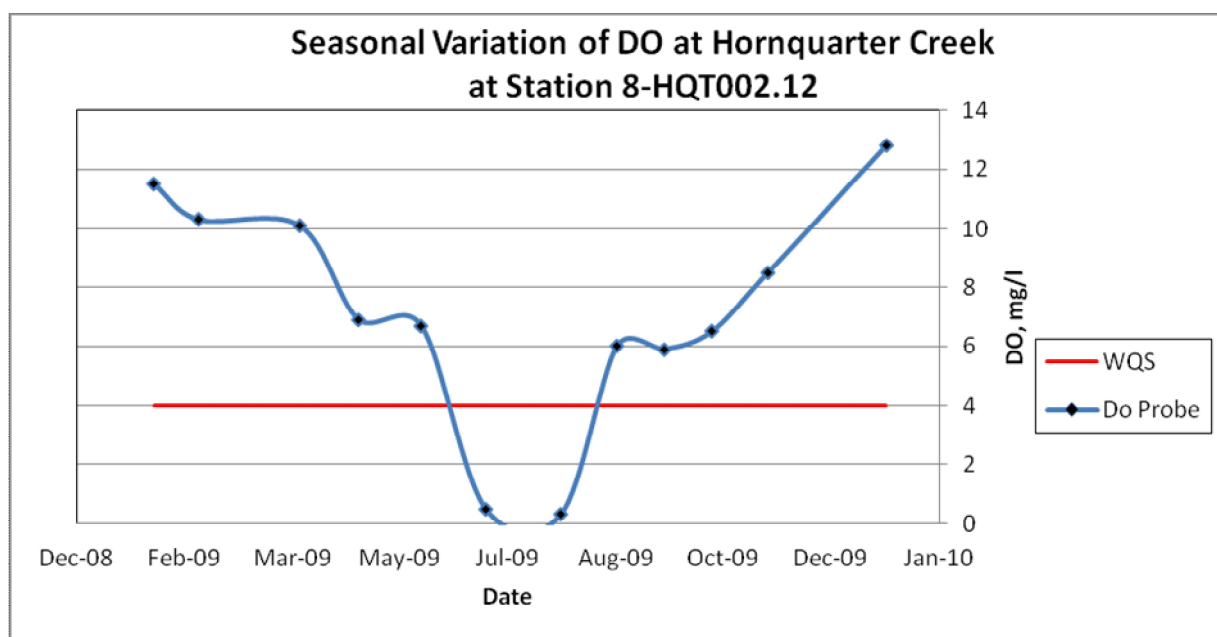
Figure 8. Seasonal DO Variation at Hornquarter Creek at Rt. 614, January – December 2009.

The 2009 DO data collected at the Hornquarter Creek original listing station 8-HQT002.12 were graphed to demonstrate the natural seasonal DO fluctuation due to the inverse relationship between water temperature and DO. DO is high in the winter months while water temperatures are low, and low in the summer months when water temperatures are high. This is depicted in Figure 8.
